498 Main Street, East Berlin

1985 Townwide Historic and Architectural Survey of Berlin, Connecticut. Survey # 100

IDENTIFICATION		DESCRIPTION	
1. BUILDING NAME (Common)		Julius W. Burr House	
2. TOWN/CITY	VILLAGE	COUNTY	
Berlin	East Berlin	Hartford	
3. STREET AND NUMBER (and/or location)		23-1/144/15

Julius W. Burr House

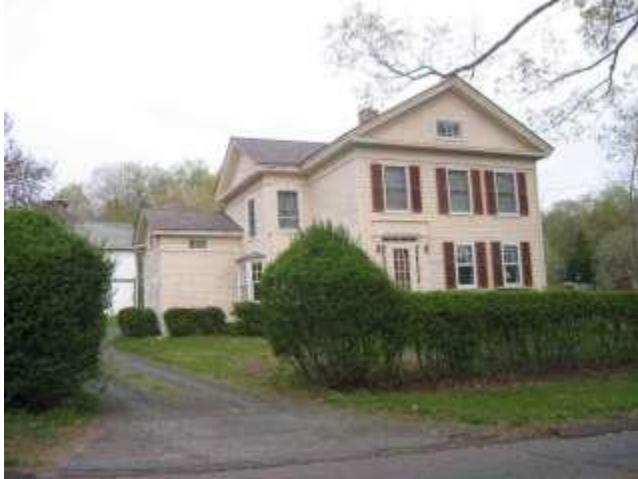
Greek revival

Julius Burr built this house in 1850 and remained in family until 1920s. He was a blacksmith.

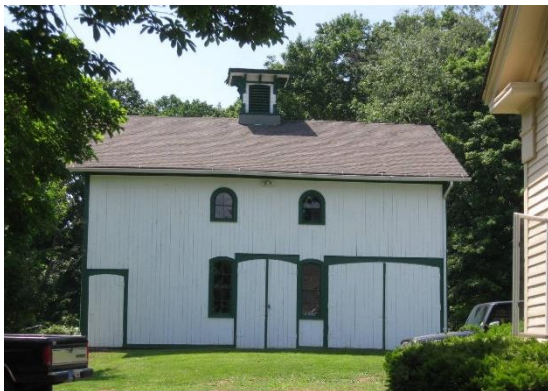
Barn at 498 Main Street, East Berlin

12-over-12 sash. Behind the house is a Victorian barn with a flat-roofed bracketed cupola.

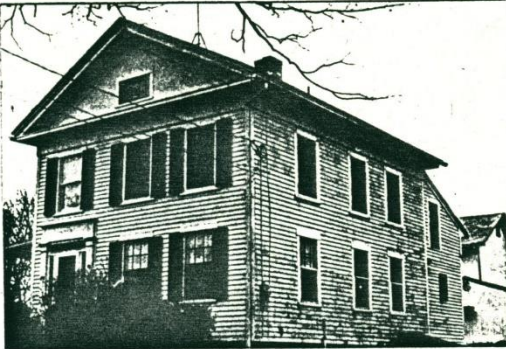
VIEW SW; W	NEGATIVE ON FILE D 35; D 36	
	NAME Historic Resource Consultants	DATE 12/84	
	ORIGIN The Colt Armory 55 Van Dyke Avenue Hartford, Connecticut 06106		
20 SUBSEQUENT FIELD EVALUATION:

DESCRIPTION (Continued)	17 OTHER NOTABLE FEATURES OF BUILDING OR SITE (interior and/or exterior)	
	<p>The Julius W. Burr House has a three-bay facade with a left entry. The trabeated entry has side and transom lights, plain pilasters with molded capitals, and a wide plain frieze with a simple molded cap. The heavy six-paneled entry door is old if not original. Windows are fitted with a mixture of sash and have plain board surrounds. First-floor windows on front and side elevations have wide board lintels. The molded main roof cornice has a wide plain frieze and shows a full return across the flushboarded tympanum. The rectangular attic lights has border pane glazing. On the left elevation are two old or original ells with old 6-over-6 sash. The front ell has a plain board entablature with a single frieze band window. The rear elevation has an old or original shed-roofed extension with</p> <p style="text-align: right;">(continued)</p>

SIGNIFICANCE	19 HISTORICAL OR ARCHITECTURAL IMPORTANCE	
	<p>Architecturally, the Julius W. Burr House is significant as a well-preserved example of the Greek Revival style. The gable-to-street orientation, trabeated entry, flushboarded tympanum, and wide plain board lintels are all intended to suggest the massing and smooth masonry construction of the classical Greek temple.</p> <p>Julius W. Burr built this house about 1850 on land bought from Harley Bowers. It remained in the Burr Family until the 1920s.</p>
